NUMBER: 08-017-13

Flash: Vehicle Theft Alarm Intermittently Sounds

2011 - 2012 (WK) Grand Cherokee (International only)

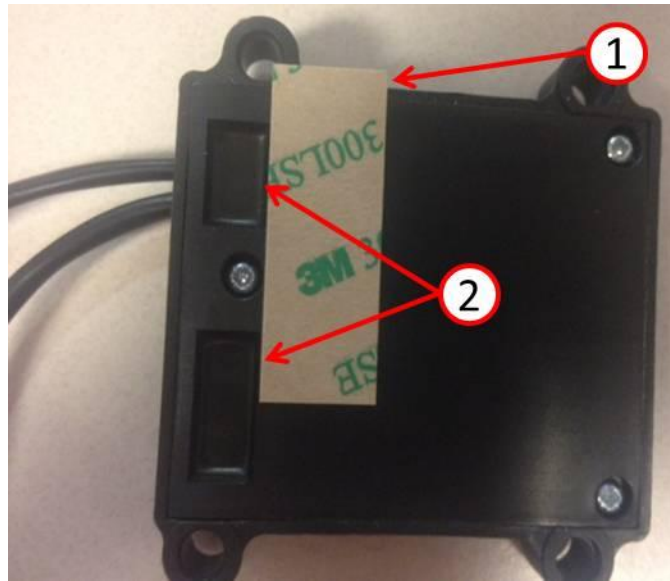
Fig. 1 Module and Tape Placement Location

This could be caused by the overhead console not retaining the intrusion module in place as well as it should. With the module not properly secured and with temperature changes, the wiring stiffens and relaxes moving the module. This set's off the alarm.

1 - Leave a tab at this location.

2 - Line up the tape along these indents.

NOTE: There are 2 pieces of tape in the package. Only one piece of tape is needed, the 2nd piece of tape is used as a back up.

- 6. Reinstall the module, putting slight pressure on the module to seat the tape.
- 7. Install the overhead console, follow procedure in TechCIONNECT, 23 - Body/Interior/CONSOLE, Overhead/Installation.
