**NUMBER:** 08-020-17 REV. A

**GROUP:** Electrical

**DATE:** May 19, 2017

Flash: Hands Free Module (HFM) Enhancements

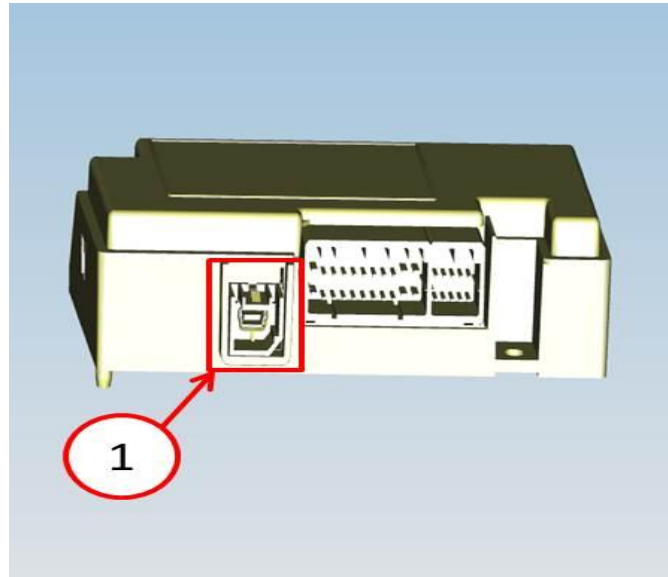
**Fig. 6 USB Update Cable Port Location**

1 - Port to Plug USB cable #68086985AB into

20. Plug USB cable #68086985AB into the open port on the HFM (Fig. 6).
