NUMBER: 08-025-18 REV. A

GROUP: 08 - Electrical

RA3 and RA4 Radio Enhancements

This bulletin involves inspecting and if required, updating the radio software.

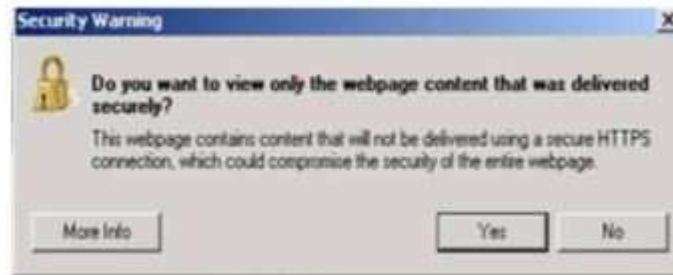
Fig. 1
Pop-up Security Message

3. If a security message appears "Do you want to view only the webpage content that was delivered securely?" (Fig. 1) Press "No" to continue.

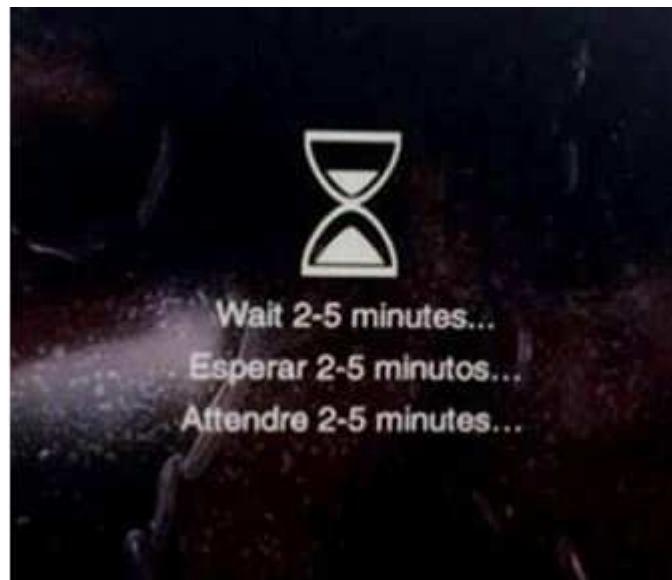
Fig. 2
Hourglass Screen

NOTE: During the update process you may see multiple hourglass screens for extended periods of time (several minutes) (Fig. 2) . DO NOT remove the USB flash drive at this time. Only remove the USB flash drive when the update has completed, when the screen displays the software levels again.

NOTE: During the update process, the screen on the radio will display an hourglass two separate times for approximately two to five minutes at a time. See (Fig. 2) .

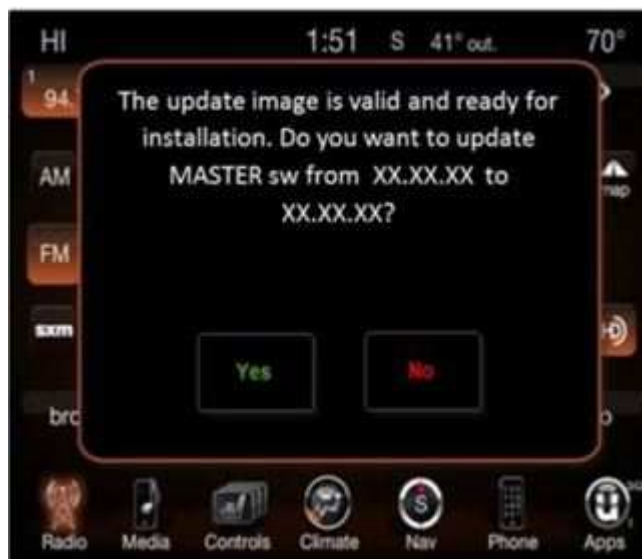
**Fig. 3
Updated Software Screen**

10. After the update is done the screen will display the software levels again. (Fig. 3) .
