NUMBER: 08-037-18

Engine Harness Rubbing on Intermediate Shaft

2018 (WK) Jeep Grand Cherokee

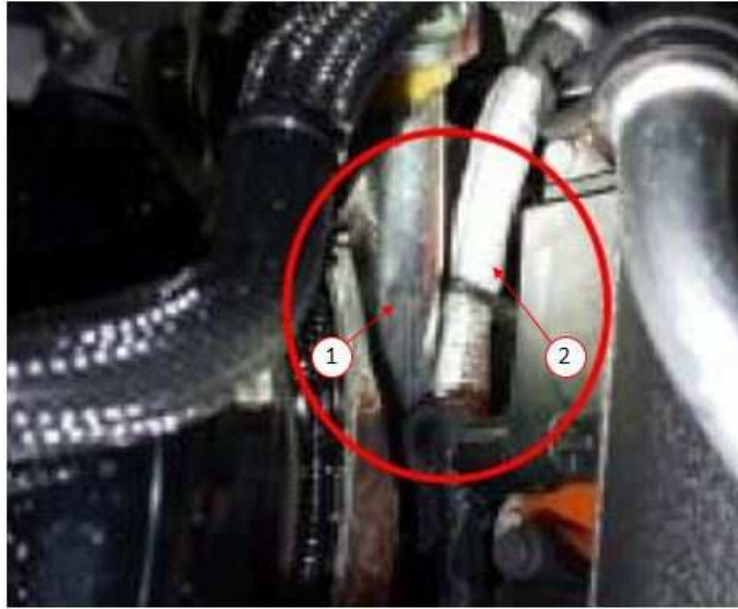
Fig. 2
Wire Harness Location

The customer may notice that the engine harness is rubbing on the intermediate shaft.

5. Locate engine harness next to the intermediate shaft. See (Fig. 2) .
