NUMBER: 08-070-13 REV. C

RHR RHW Or RHP Radio Navigation Map Enhancements

This bulletin involves updating the RHR,RHP or RHW radios navigation map database software.

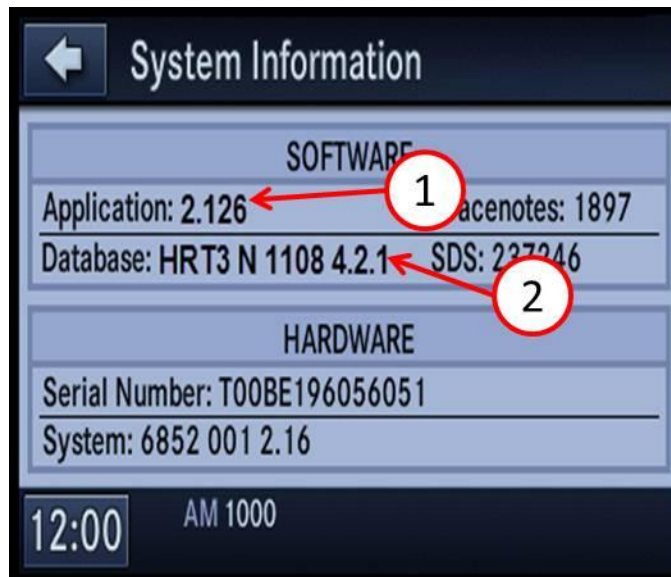
Fig. 4 Software Versions

1 - Application Version
2 - Database Software Version

-
- 6. Is the application software level at 2.184? (Fig. 4).
 - a. No >>> Perform service bulletin 08-066-13 first, before proceeding with this bulletin.
 - b. Yes >>> proceed to [Step #7](#).

7. Is the database software level at 4.3.1 or higher? (Fig. 4).
 - a. Yes >>> This service bulletin doesn't pertain, normal diagnostic should be performed.
 - b. No >>> Proceed to [Step #8](#).
8. An activation key is required and must be obtained by going to <http://www.navteq.com/freshmaps/chryslerdealers>. You must have the vehicle VIN before you can obtain a functional activation key.
