NUMBER: 08-086-13

DATE: October 30, 2013

Exterior Lamp Condensation And Fogging

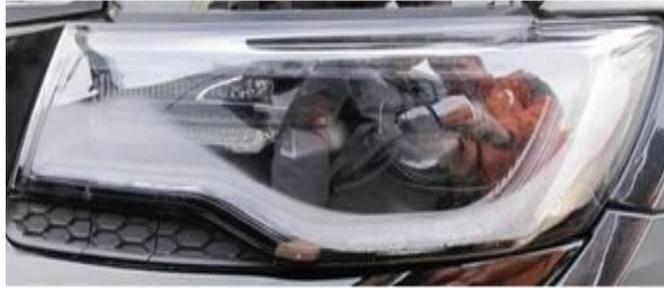
If the condensation/fogging has begun to clear from the lamp lens after 20 minutes with the lamps operating, this indicates the lamp sealing has not been breached, and the lamp does not need to be replaced ([Fig. 1](#)).

Fig. 1 Condensation Fogging Do Not Replace

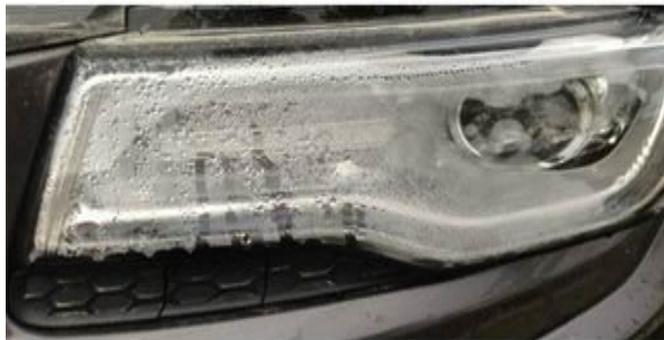
If the condensation/fogging has not begun to clear after 20 minutes with the lamps operating, or the lamp has large amounts of water droplets visible on most internal surfaces, this indicates an issue with the lamp sealing that has allowed water to enter the lamp. In this instance, the customer is also likely to report that moisture in the lamp is always present and never disappears. A lamp that exhibits internal moisture permanently should be replaced ([Fig. 2](#)).

Fig. 2 Heavy Water Droplets Replace
