**NUMBER:** 08-089-17

Horn Replacement

2017 (WK) Jeep Grand Cherokee

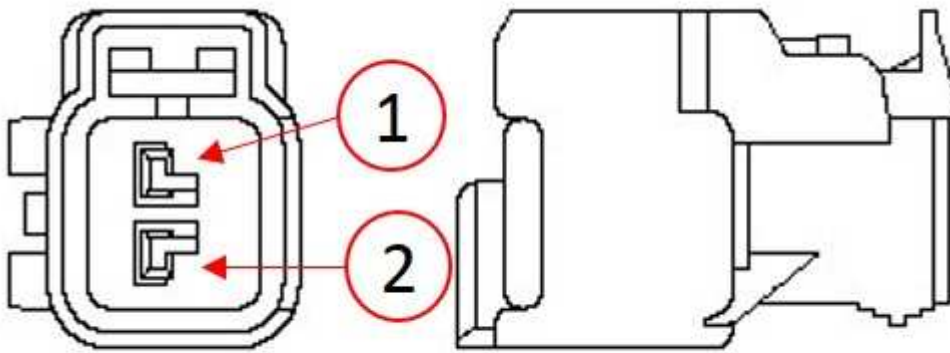
**Fig. 1**  
**Horn Electrical Connector**

1 - Ground Cavity  
2 - 12V Cavity

2. Cut the old electrical wiring harness connectors from both horns and dispose.
3. Use connector kit #68018954AA and replace both horn electrical connectors (Fig. 1) . Insert Dark Blue wire into Cavity 1 and then splice into Black Ground vehicle harness wire. Refer to the detailed service procedures available in DealerCONNECT> TechCONNECT under: Service Info>29 - Non-DTC Diagnostics/Circuit Testing Procedures/Standard Procedure>Wire Splicing.

4. Insert Dark Blue wire into Cavity 2 and then splice into Grey with Yellow tracer vehicle harness wire. Refer to the detailed service procedures available in DealerCONNECT> TechCONNECT under: Service Info>29 - Non-DTC Diagnostics/Circuit Testing Procedures/Standard Procedure>Wire Splicing.
