NUMBER: 18-010-17

Engine Oil Viscosity Upgrade And Flash Enhancements

2016	(WK)	Jeep Grand Cherokee
2016	(DS)	RAM 1500 Pickup

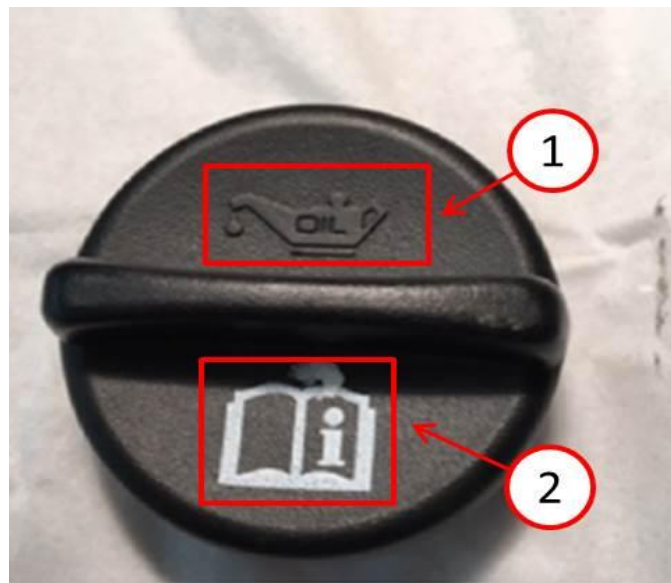
Fig. 1 Cap Before Sticker Applied

- 1 - Do Not Cover This Embossed International Oil Symbol
- 2 - Cover This Old Oil Info Symbol With The New "5W40" Label

5. Run engine for 10 minutes before oil change to warm up the engine oil.
6. Remove oil fill cap.
7. Clean top of oil fill cap with Isopropyl alcohol or equivalent and apply engine oil viscosity rating sticker as shown in (Fig. 1).

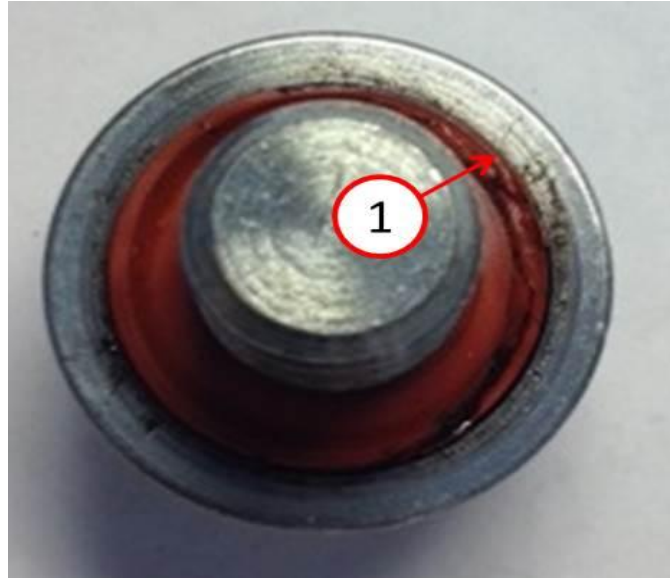
Fig. 2 Damaged Rubber Seal

1 - Oil Drain Plug Gasket Seal Crushed

9. Inspect the oil drain plug and gasket for damages ([Fig. 2](#)). Replace if necessary.

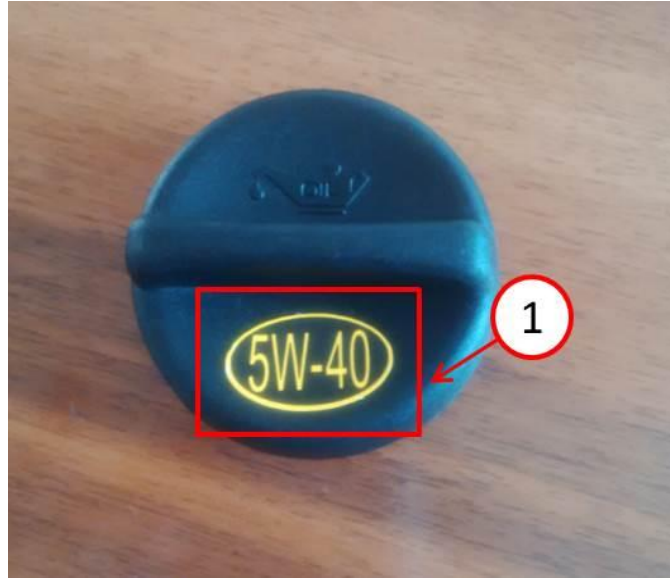
Fig. 3 Cap After Sticker Applied

1 - "5W-40" Sticker Affixed To Oil Filler Cap

12. Replace the oil fill cap with the new 5W-40 sticker firmly attached (Fig. 3).
