**NUMBER:** 08-020-17 REV. A

**GROUP:** Electrical

**DATE:** May 19, 2017

Flash: Hands Free Module (HFM) Enhancements

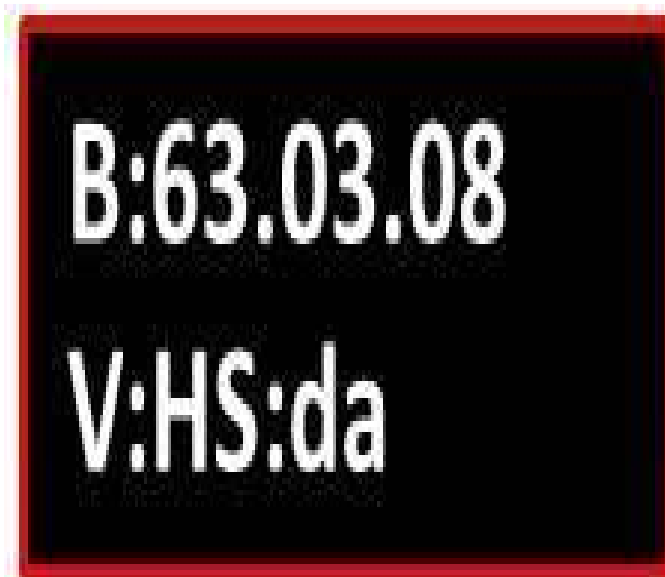
**Fig. 1 Software Versions A**

10. After hearing the beep, say "Setup-Software Update".
11. The HFM software version will now be displayed on the radio display screen.
12. Is the software version one of the following:
  - a. For Wrangler, Grand Caravan, Town & Country, Grand Cherokee and Durango with **Sales Code RSP** radios at B:63.03.08 / V:HS:da ([Fig. 1](#))?

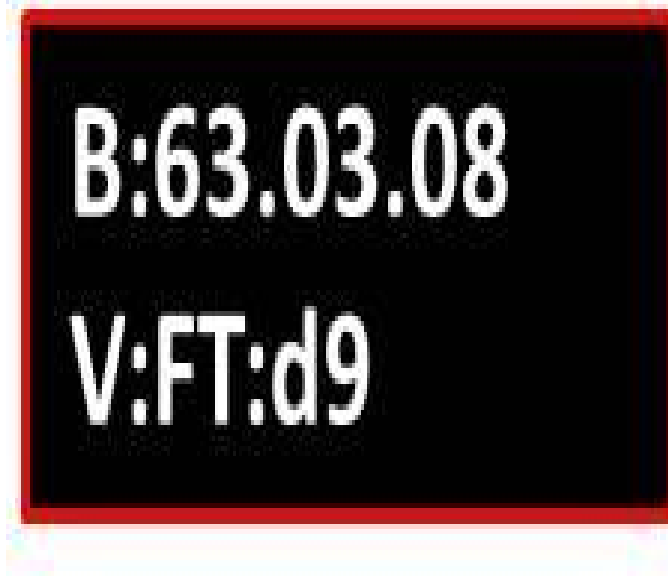
***Fig. 2 Software Versions B***

- b. For Patriot, Compass, Avenger, 200 and Challenger with **Sales Code RSP** radios at B:63.03.08 / V:FT:d9 ([Fig. 2](#))?

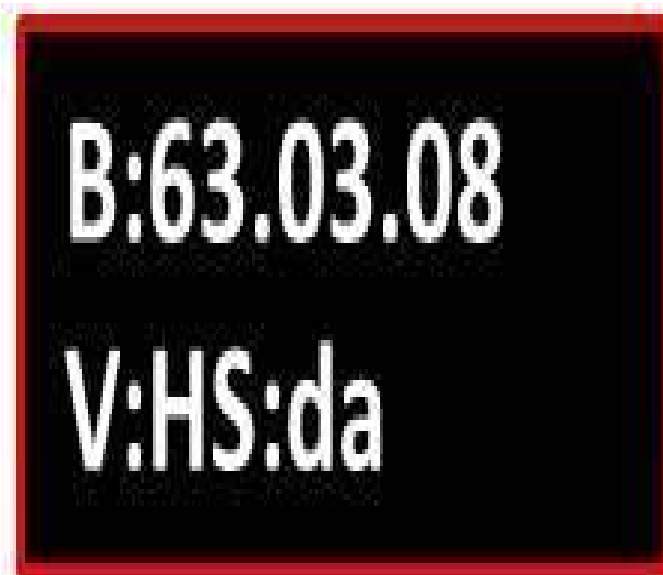
**Fig. 7 Software Versions A**

35. Is the software version one of the following:
  - a. For Wrangler, Grand Caravan, Town & Country, Grand Cherokee and Durango with **Sales Code RSP** radios at B:63.03.08 / V:HS:da ([Fig. 7](#))?

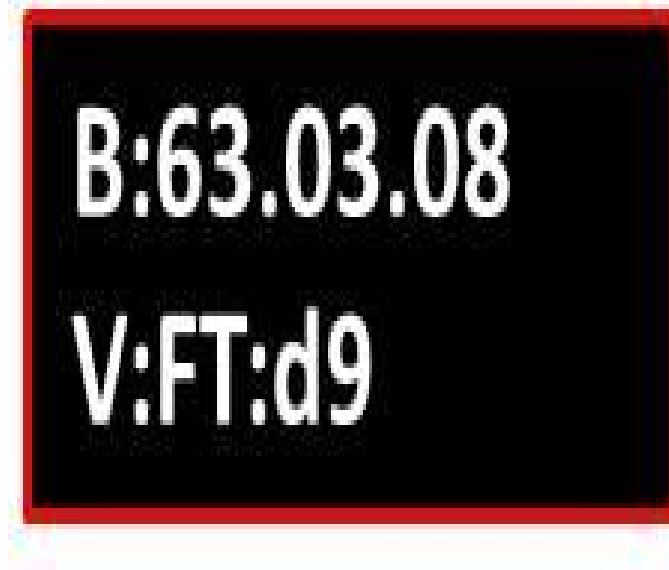
***Fig. 8 Software Versions B***

- b. For Patriot, Compass, Avenger, 200 and Challenger with **Sales Code RSP** radios at B:63.03.08 / V:FT:d9 ([Fig. 8](#))?

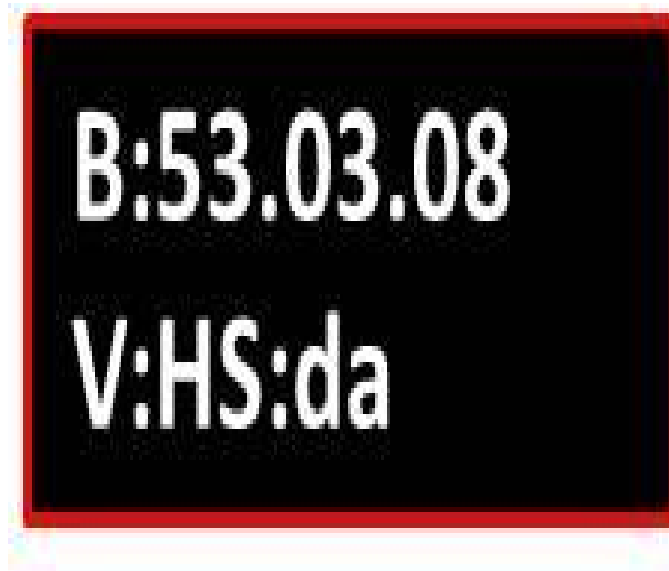
***Fig. 9 Software Versions C***

- c. For Wrangler, Grand Caravan, Town & Country, Grand Cherokee and Durango with **Sales Code RSQ** radios at "B:53.03.08 / V:HS:da (Fig. 9)?

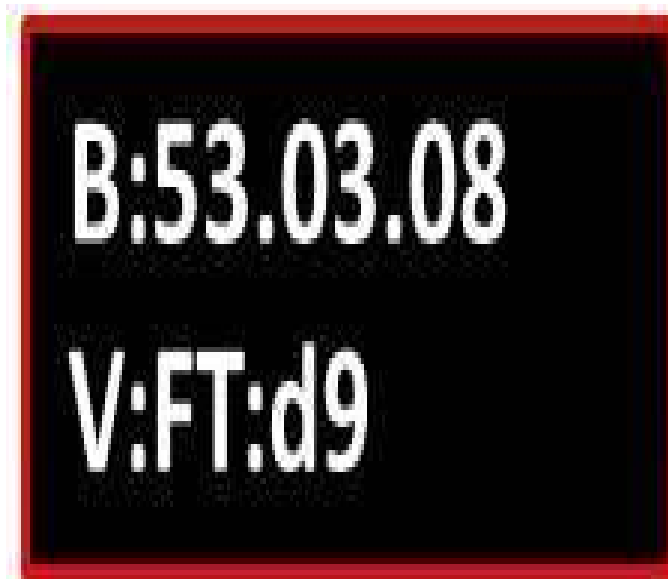
**Fig. 10 Software Versions D**

- d. For Patriot, Compass, Avenger, 200 and Challenger with **Sales Code RSQ** radios at B:53.03.08 / V:FT:d9 (Fig. 10)?
