NUMBER: 08-017-18 REV. A

GROUP: 08 - Electrical

RJ3, RJ4, RG3 and RG4 Radio Enhancements

This bulletin involves inspecting and if required, updating the radio software.

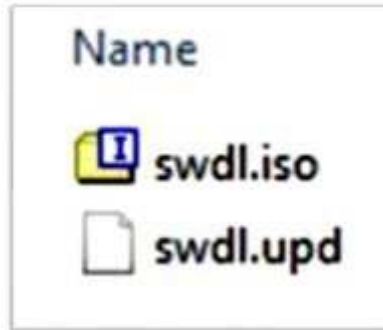
Fig. 1
Two USB Files

NOTE: Two files will be loaded onto the USB flash drive, see (Fig. 1) .

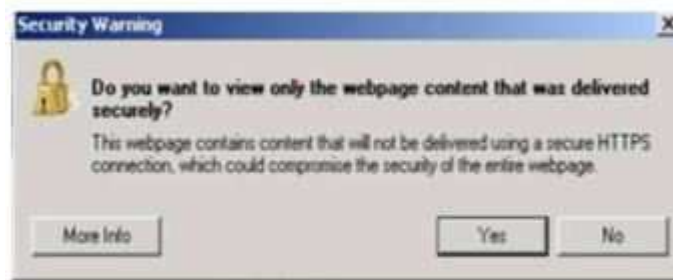
Fig. 2
Pop-up Security Message

1. Has a USB flash drive been created?
 - YES >>> Proceed to [Step 5](#).
 - NO >>> Proceed to [Step 2](#).
2. Go to DealerCONNECT> Service> Uconnect Information & Utilities> Uconnect Dealer software downloads to download the files.
3. If a security message appears “Do you want to view only the web page content that was delivered securely?” (Fig. 2) Press “No”, to continue.

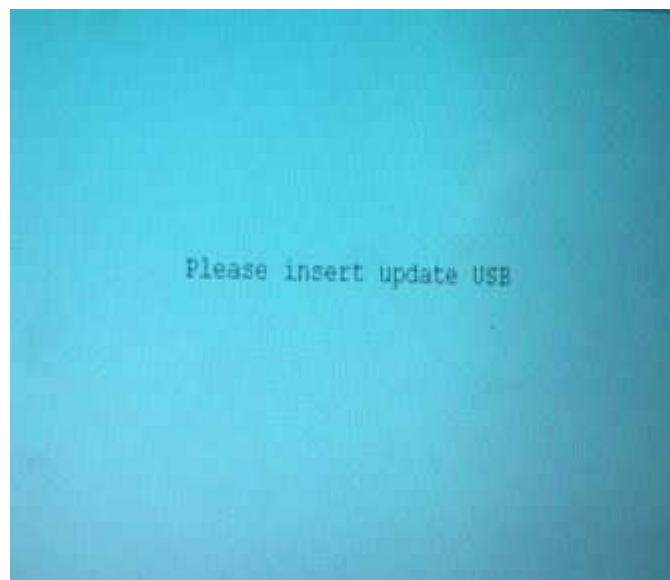
Fig. 4
Please Insert Update USB

NOTE: During the update process you will see multiple hourglass and “Please Insert Update USB” screens for extended periods of time (several minutes) (Fig. 3) or (Fig. 4) . **DO NOT** remove the USB flash drive at this time. Only remove the USB flash drive when the update has completed, when the screen displays the software levels again. The screen will say “Software updated successfully”.

NOTE: If the software update process is interrupted, aborted or failed, the process should be restarted. See Star Online Cases if the radio failed to update, or is stuck in 'update mode' displaying “Insert Update USB” and if so, re-insert the USB.

NOTE: During the update process, the screen on the radio will display an hourglass and blue screen that said “Please Insert Update USB” for approximately two to five minutes at a time ([Fig. 3](#)) and ([Fig. 4](#)) .
